# An Overview of the Symptoms Associated with Dampness in Walls of Residential Buildings in Major Towns in Ghana

Figure 1. Photographs of some symptoms associated with dampness in buildings

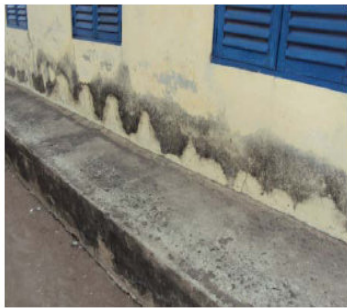
a) Stain in horizontal band

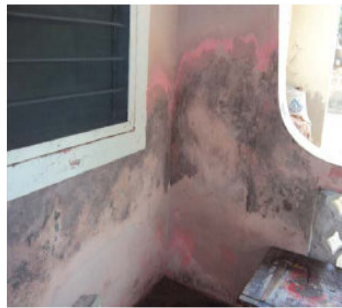
b) stain in horizontal band

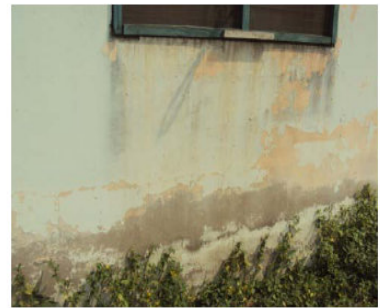
c) water run marks on windows

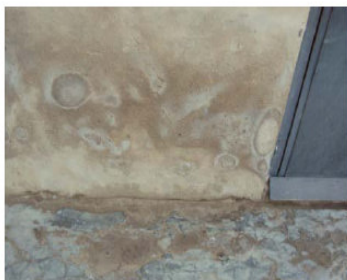
d) Surface efflorescence

Cyclic wetting and drying brought about by seasonal changes is an important driver of salt attack or efflorescence in walls of buildings (Young, 2008). Changes in the relative humidity of a location can cause efflorescence to occur (Young, 2008). Surface efflorescence in walls is caused by rapid evaporation of water from wall surfaces leaving behind salt crystals (Young, 2008). In the Dry Equatorial Climatic zone, there is that tendency of rapid evaporation of moisture from walls of buildings which could lead to the formation of salt bands on the surfaces of walls. A reason why surface efflorescence is the most severe symptom of dampness associated with buildings in this climatic zone.

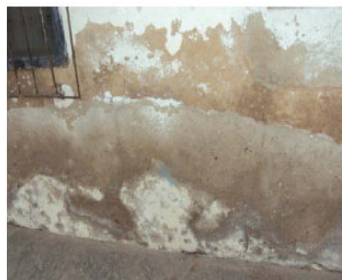
e) Surface efflorescence

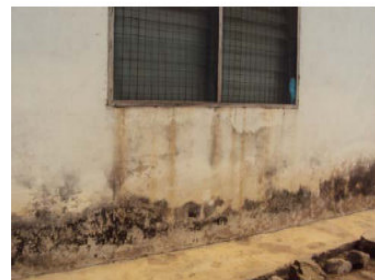
f) Water run marks on window

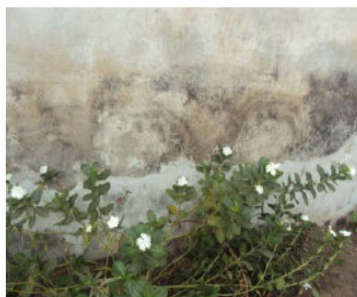
g) Damp at the base of wall

Rising dampness occurs as a result of capillary suction of moisture from the ground into porous masonry building materials such as stone, brick, blocks, earth and mortar (Halim & Halim, 2010; Ahmed & Rahman, 2010; Riley & Cotgrave, 2005). It is a problem that is very common in older buildings, particularly those constructed without damp proof courses. However, it is gradually becoming a common issue with modern types of buildings as well (Rirsch, 2010). Over the years, many researchers have tried to define rising dampness from their own perspectives and new definitions keep on resurfacing as the years go by. Oxley and Gobert (1989) linked 'rising dampness to the ground and concluded that it occurs from the capillary flow of water from the ground'. Melville and Gordon (1998) explained that 'when ground water reaches the foot of a wall, it tends to rise in the walling materials and continues to do so due to capillary action to various degrees of intensity'. In their book diagnosing damp, Burkinshaw and Parrett (2004) defined 'rising damp more comprehensively as moisture that travels upwards through the pore structure or through small fissures or cracks, or as water vapour against the forces of gravity, typically up a wall or through a floor from a source below the ground'. Trotman *et al.* (2004) in their book '*Understanding dampness*' defined rising damp to 'normally mean the upward transfer of moisture in a porous material due to capillary action'. According to Rirsch (2010), it is caused by ground water rising upwards through a wall, much in the same way as oil would rise through the wick of a lamp. Rising dampness is a strange phenomenon because experts in dampness issues do not agree on exactly what it is and some deny its existence (Burkinshaw, 2012). The visible symptoms of rising damp include dampness on the lower parts of walls, sometimes up to 1.5m in horizontal bands (Rirsch, 2010). Rising damp may also present itself as salty yellowy brown patches of plaster/décor just above the height of skirting boards (Burkinshaw, 2010). It tends to cause many problems to a building with associated health, environmental, social and economic implications. Rising dampness serves as a platform for the growth of fungi in wood which causes rot, deterioration of wall plasters and paints, loosening of wall papers, staining of wall surfaces, crumbling of mortar, rusting of steel and iron fasteners, etc. (Zhang, n.d).

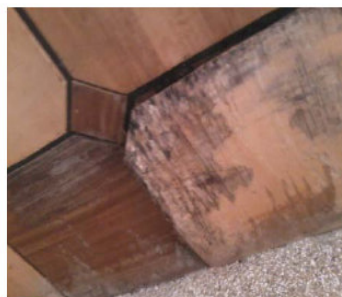
h) decayed skirting

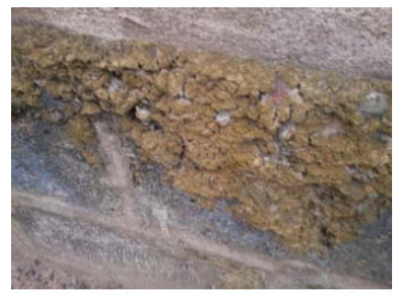
i) mould growth on wall

Dampness resulting from condensation occurs where water in the air inside a building condenses on a cooler surface (Curtis, 2007). This is usually indicative of cold spots in the building, sometimes called cold bridges (Curtis, 2007). Excessive condensation frequently results in severe mould growth which can in turn create health hazards. Damp patches can appear on plastered walls in odd places, particularly on outside walls, often appearing and disappearing on a regular basis (Burns, 2010). Condensation is mostly accompanied by mold which is black in colour but can virtually be of any colour and is very common on walls and ceiling, underneath bay windows, etc. (Burns, 2010). Running water on windows and walls is the most immediate indication of a condensation problem (Property Care Association, PCA, n.d). This problem can lead to deterioration in the decorative condition of a property, stained curtains and decay in window frames (PCA, n.d). Condensation is also associated with the appearance of moulds on the surface of wall papers and paints in poorly ventilated areas (PCA, n.d).

From the results it is seen that each climatic zone has a unique symptom associated with the walls of buildings. This is a situation likely to be caused by the differences in climatic conditions of each zone. However, these differences do not have much influence on the results obtained. For instance, mold growth highly associated with buildings in the South Western Equatorial climatic zone does not require the presence of standing water: it can occur when high relative humidity or the hygroscopic properties of building surfaces allow sufficient moisture to accumulate (United States Environmental Protection Agency, [USEPA](#), 1991). The relative humidity and temperature levels often vary within a room; therefore, if one side of the room is warm and the other side is cold, the colder side of the room has a higher relative humidity than the warmer side ([USEPA](#), 1991). The highest relative humidity in a room is always next to the coldest surface and this is likely to be the location where the first condensation occurs ([USEPA](#), 1991). In the South Western Equatorial climatic zone, average monthly relative humidity levels (based on figures recorded each day at 12 noon) are highest as compared to the other climatic zones in Ghana and range between 75-80%, a possible reason for walls being affected by mold growth in this zone.
